AN INVESTIGATION INTO THE AESTHETIC AND
PSYCHOLOGICAL EFFECTS OF THE SOILING AND
CLEANING OF BUILDING FACADES

Christopher A. Andrew

A Thesis Submitted for the Degree of PhD
at the
University of St Andrews

1994

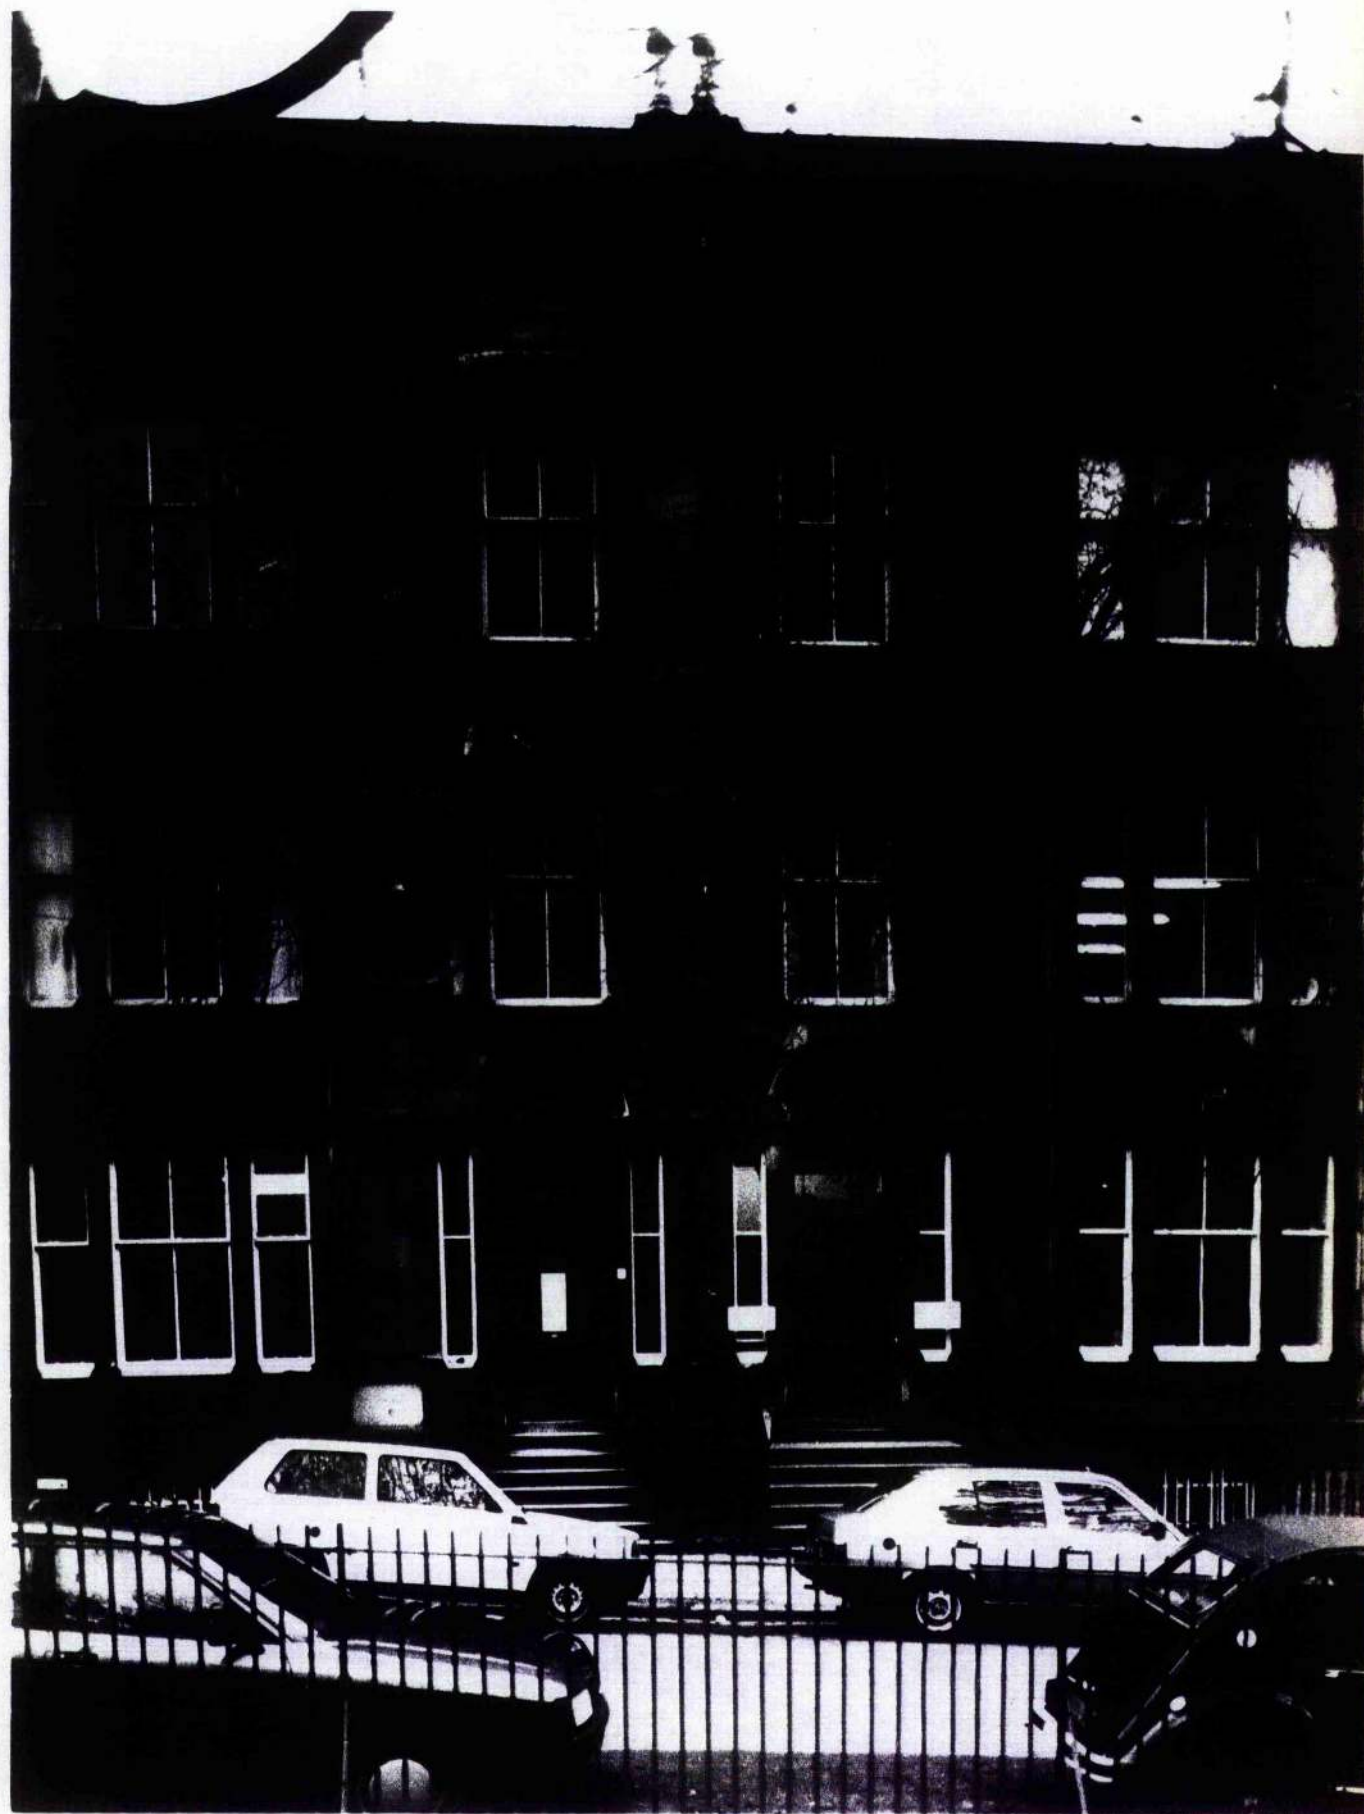
Plate 9.1 4/5 La Belle Place, Glasgow.

Plate 9.2 2/3 La Belle Place, Glasgow.

Figure 9.1 Comparison of soiled and cleaned buildings in La Belle Place, Glasgow

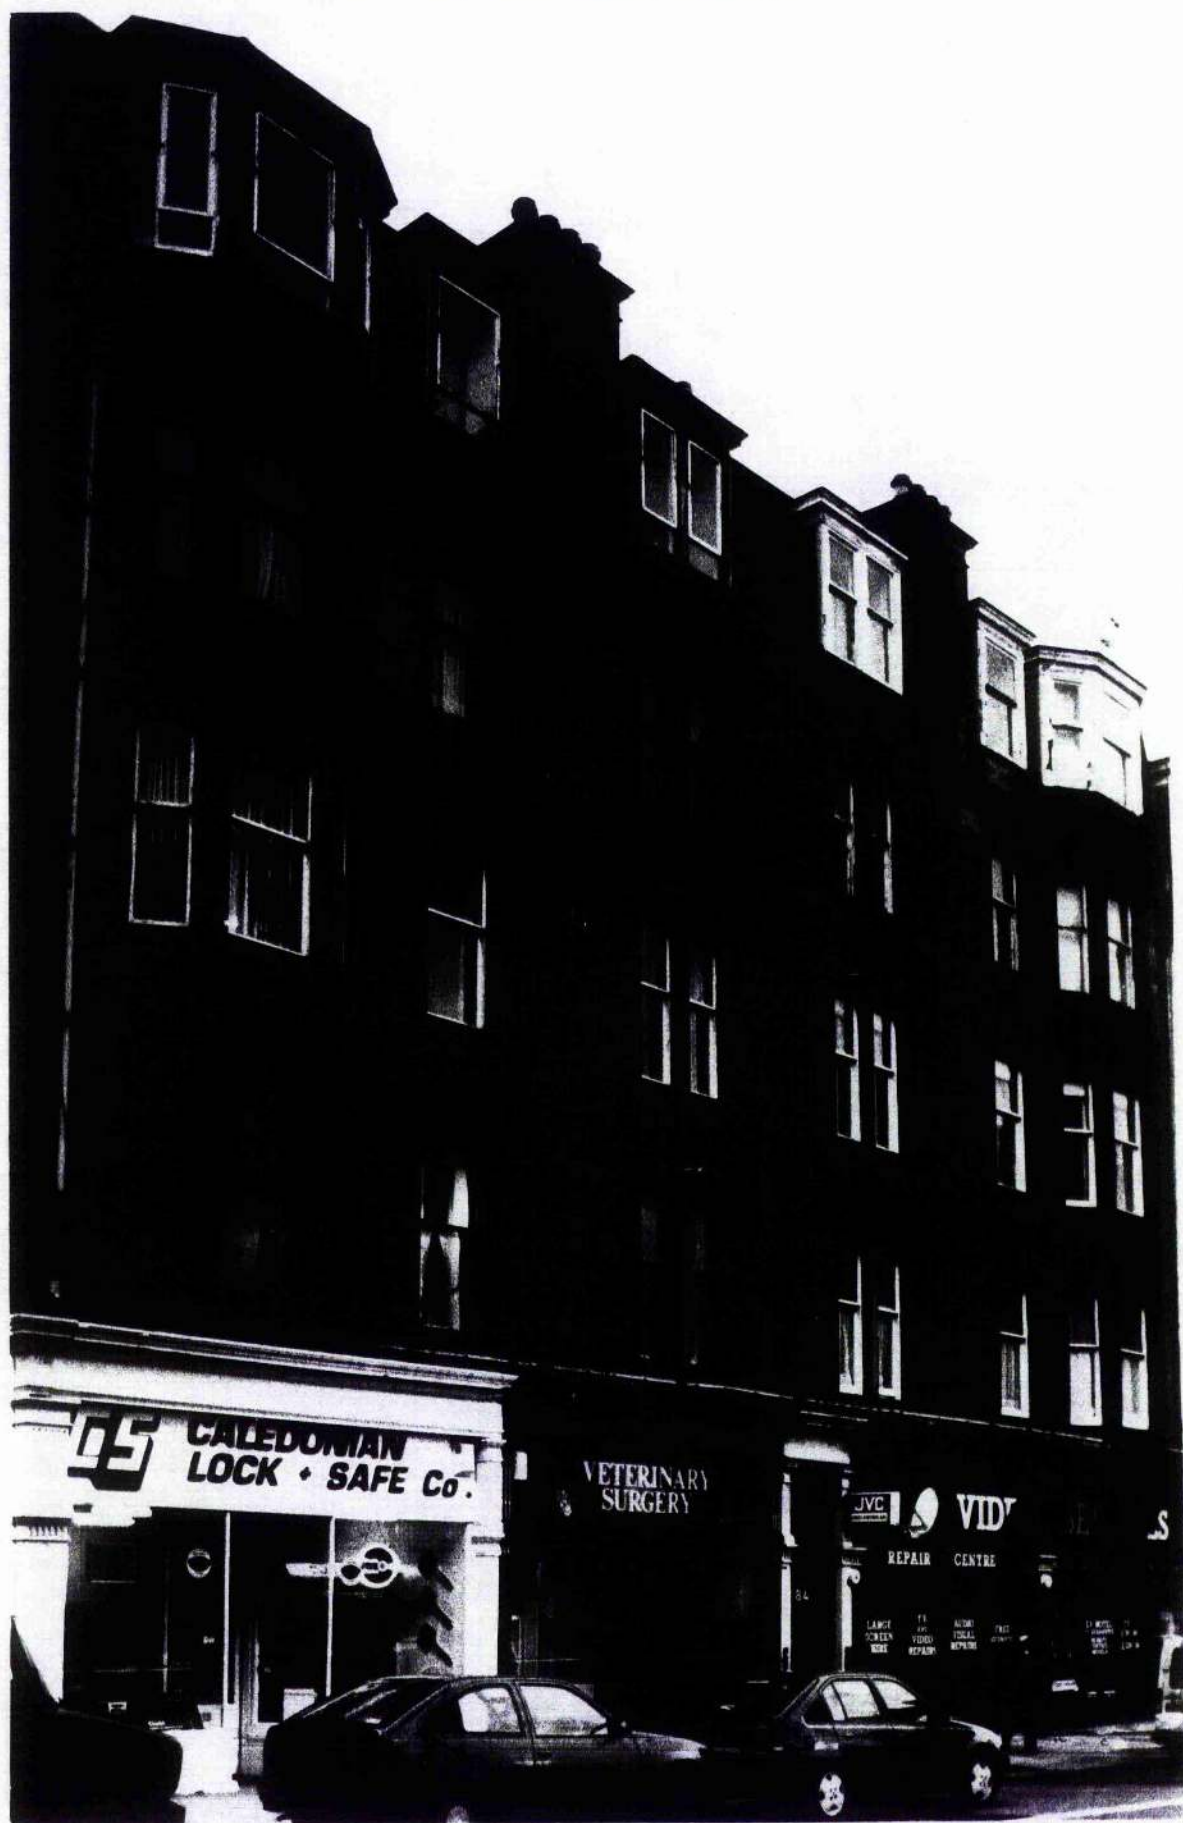
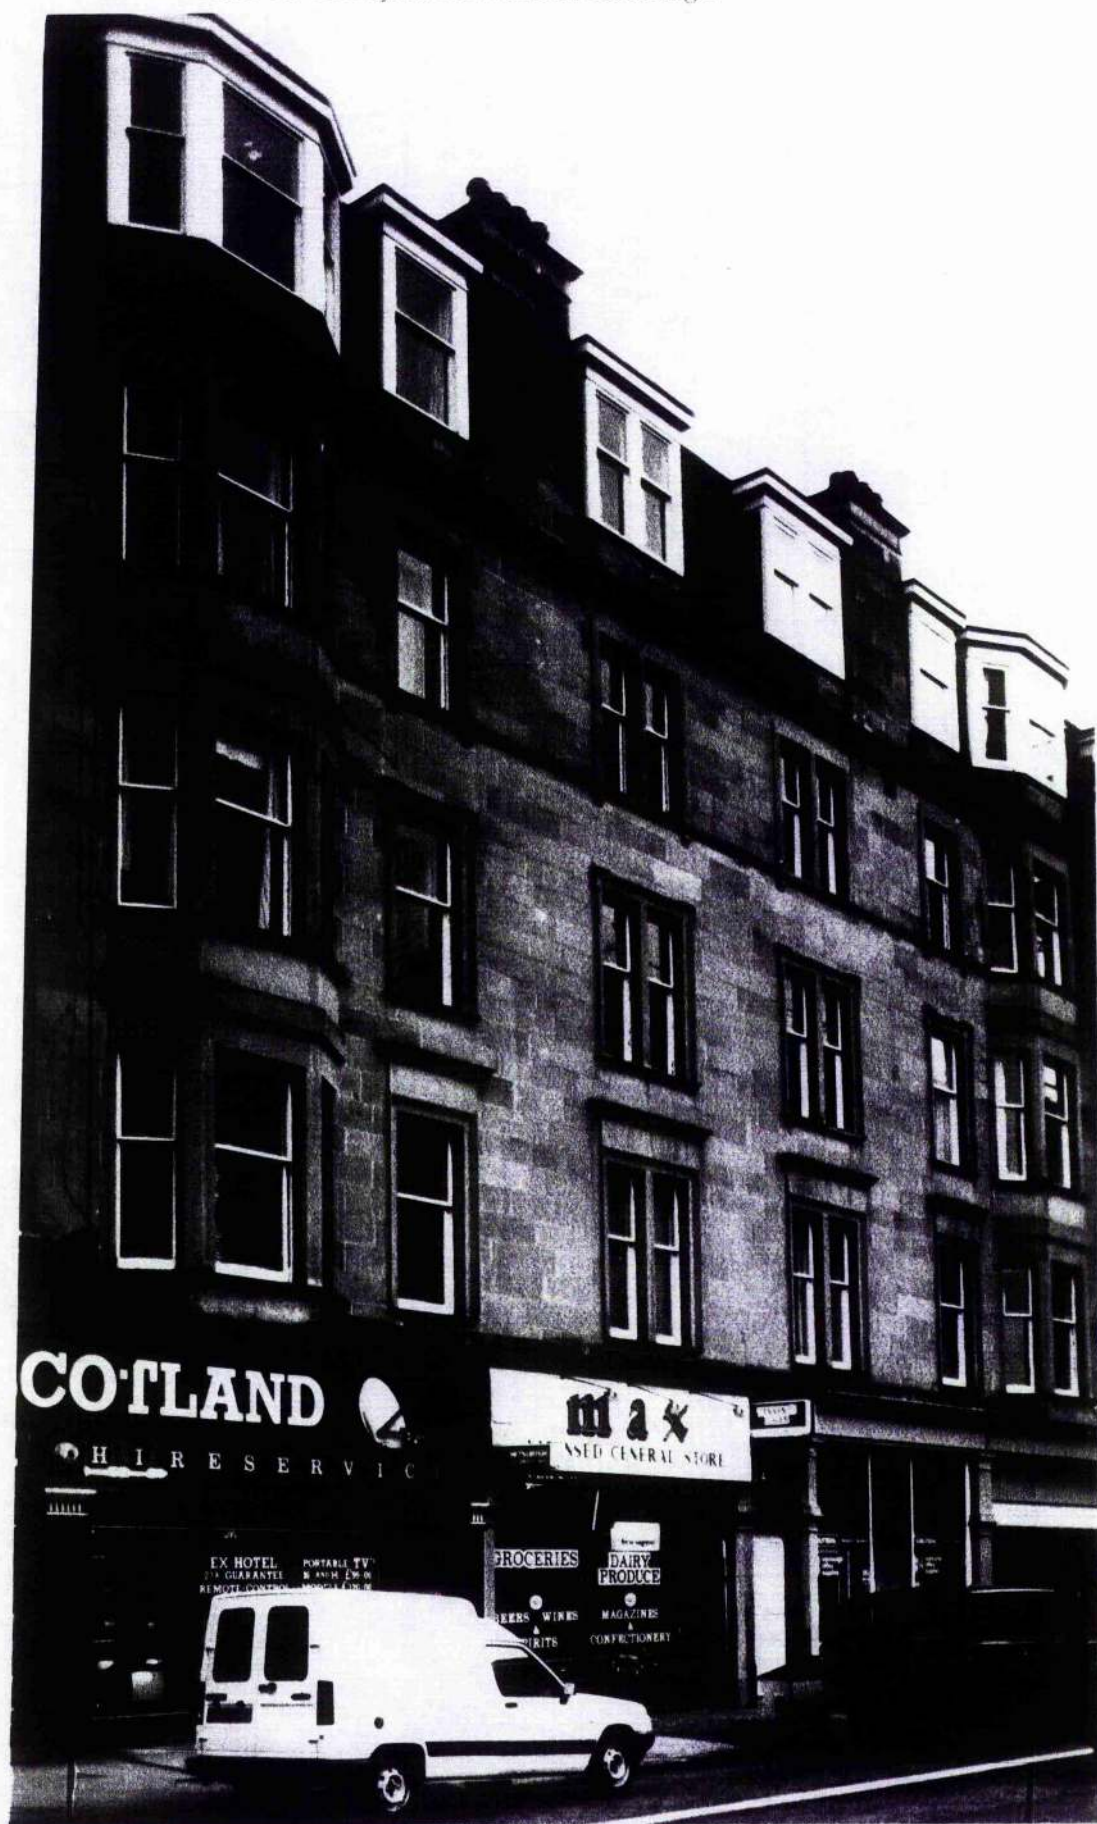
Plate 9.3 84 Haymarket Terrace, Edinburgh.

Plate 9.4 74 Haymarket Terrace, Edinburgh.

Figure 9.2 Comparison of soiled and cleaned buildings in Haymarket Terrace, Edinburgh

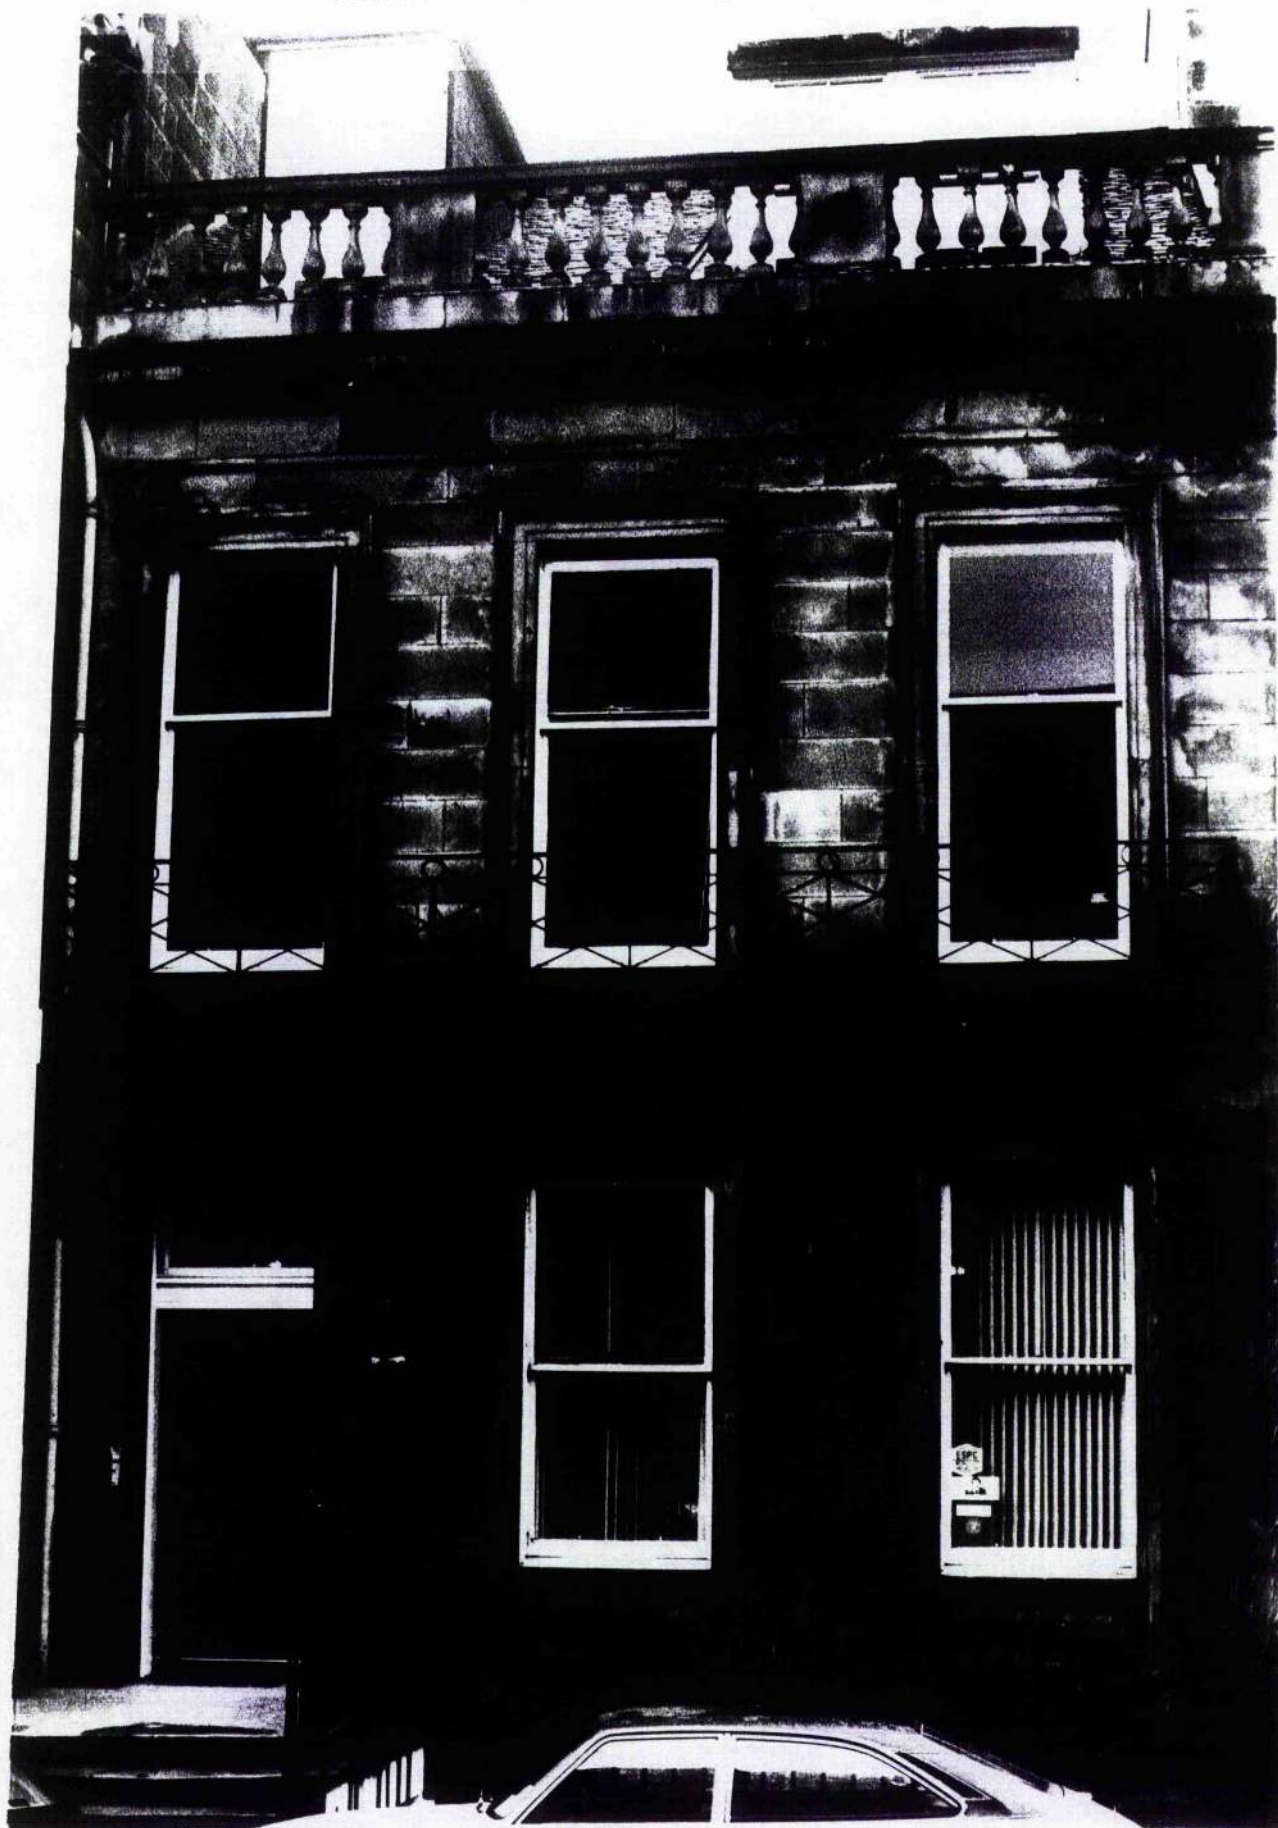
Plate 9.9 25 Rutland St., Edinburgh.

A significant difference ($P < .01$) was also found in the estimated ages of the buildings. The mean value of the estimated date of 25 Rutland Street being 1885 compared to 1906 for 23 Rutland Street.

The results of the Wilcoxon analysis of the Rutland Street data (Figure 9.5) revealed significant differences at the 1% level on all of the semantic differentials except:-

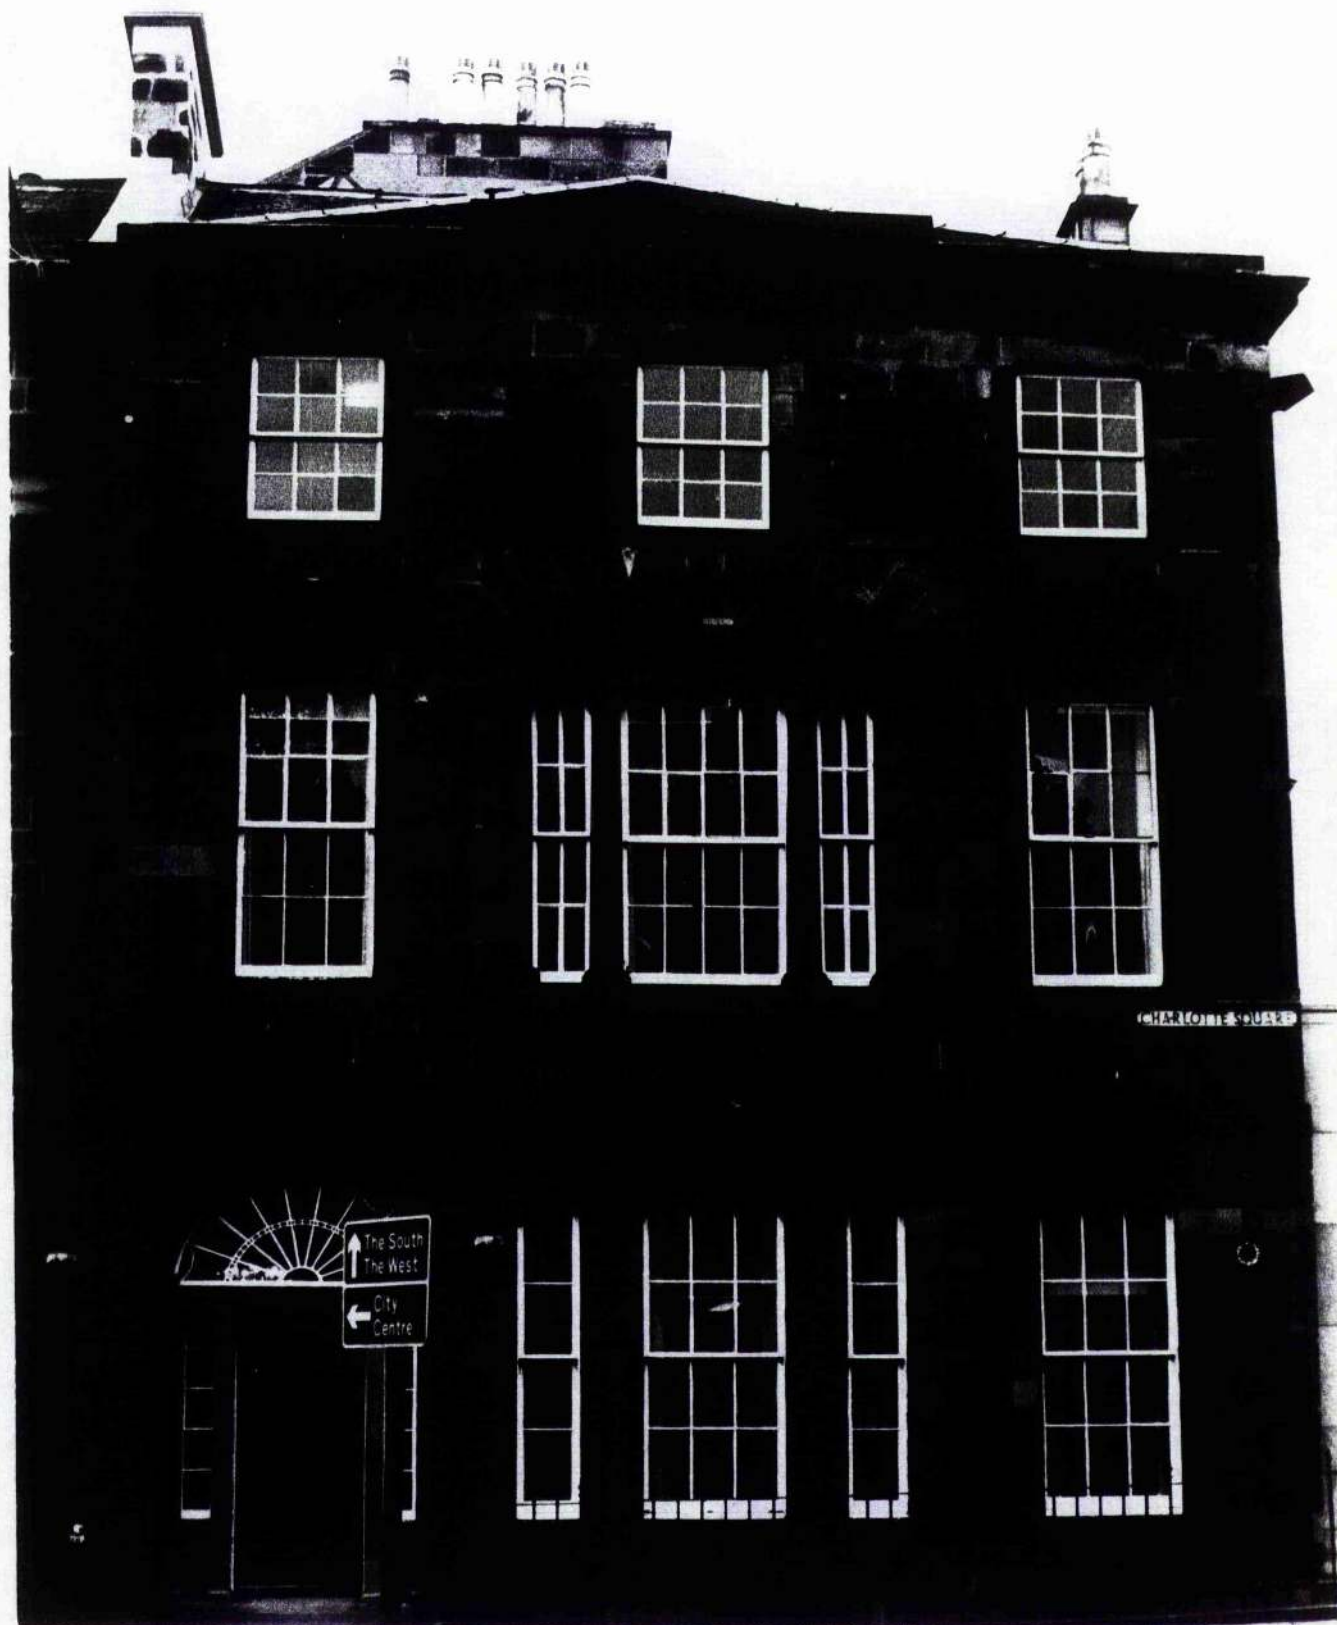
Plate 9.17 40 Charlotte Square, Edinburgh.

Although not significant, there was a tendency to judge the cleaned facade as being slightly younger than the soiled facade. The actual date of the buildings are much older than those estimated.

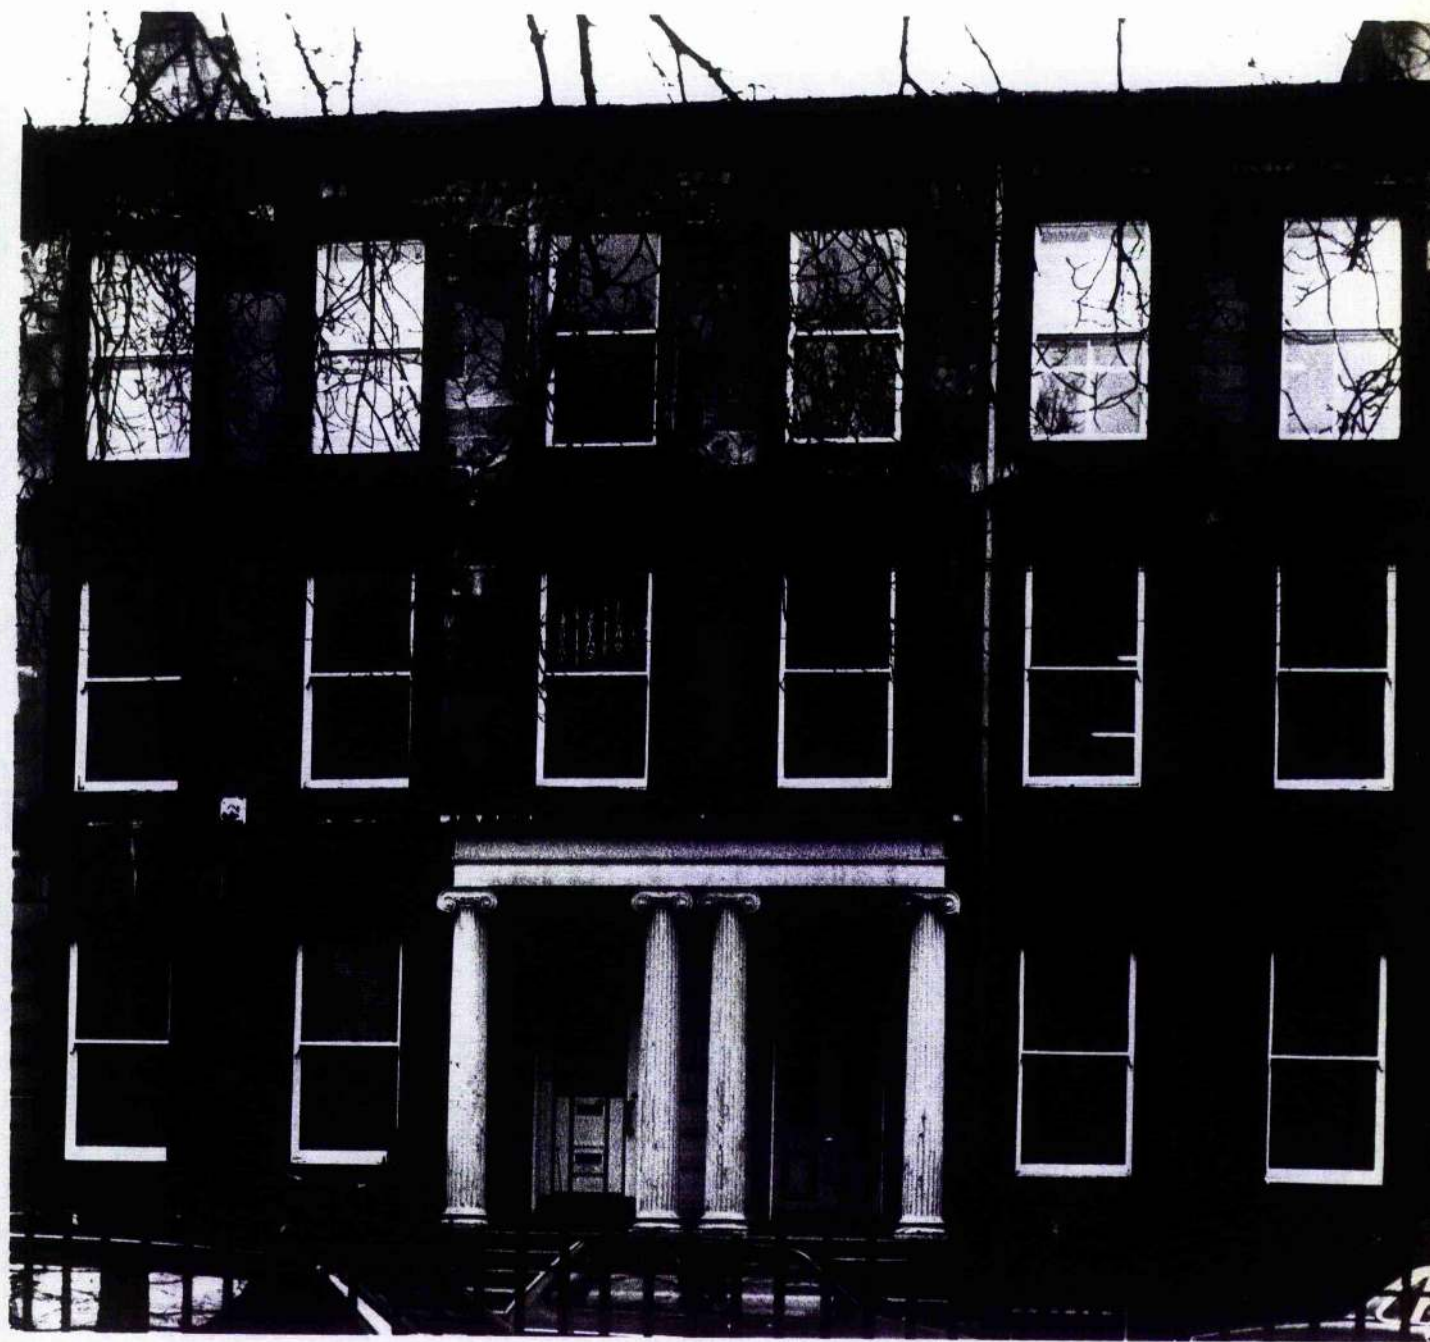
Plate 9.19 12/13 Royal Terrace, Glasgow.

There was also a tendency to view the soiled building as older than the cleaned building, but again the estimated age was later than the actual date of construction.

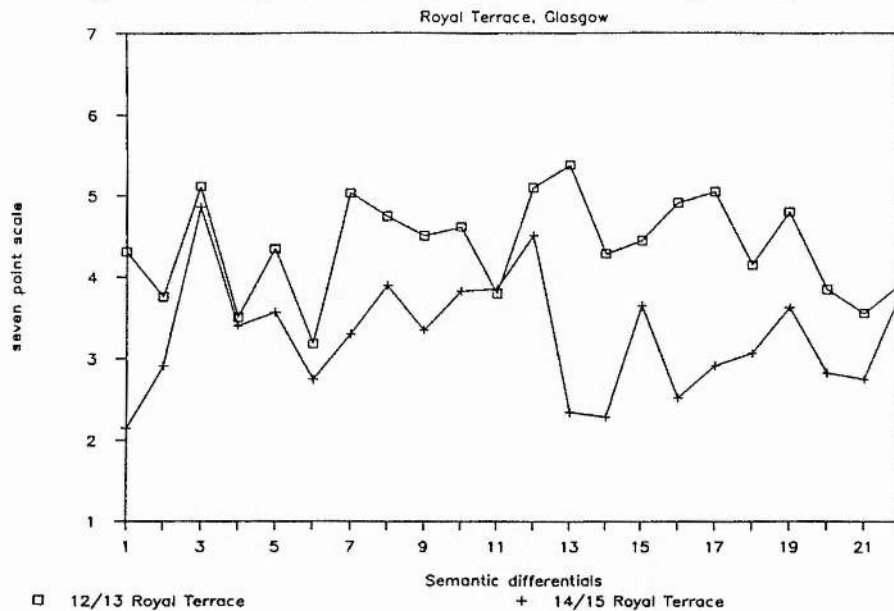
Figure 9.10 Comparison of scored and cleaned buildings in Royal Terrace, Glasgow

N=67 Analysis:- Minitab. Wilcoxon test.

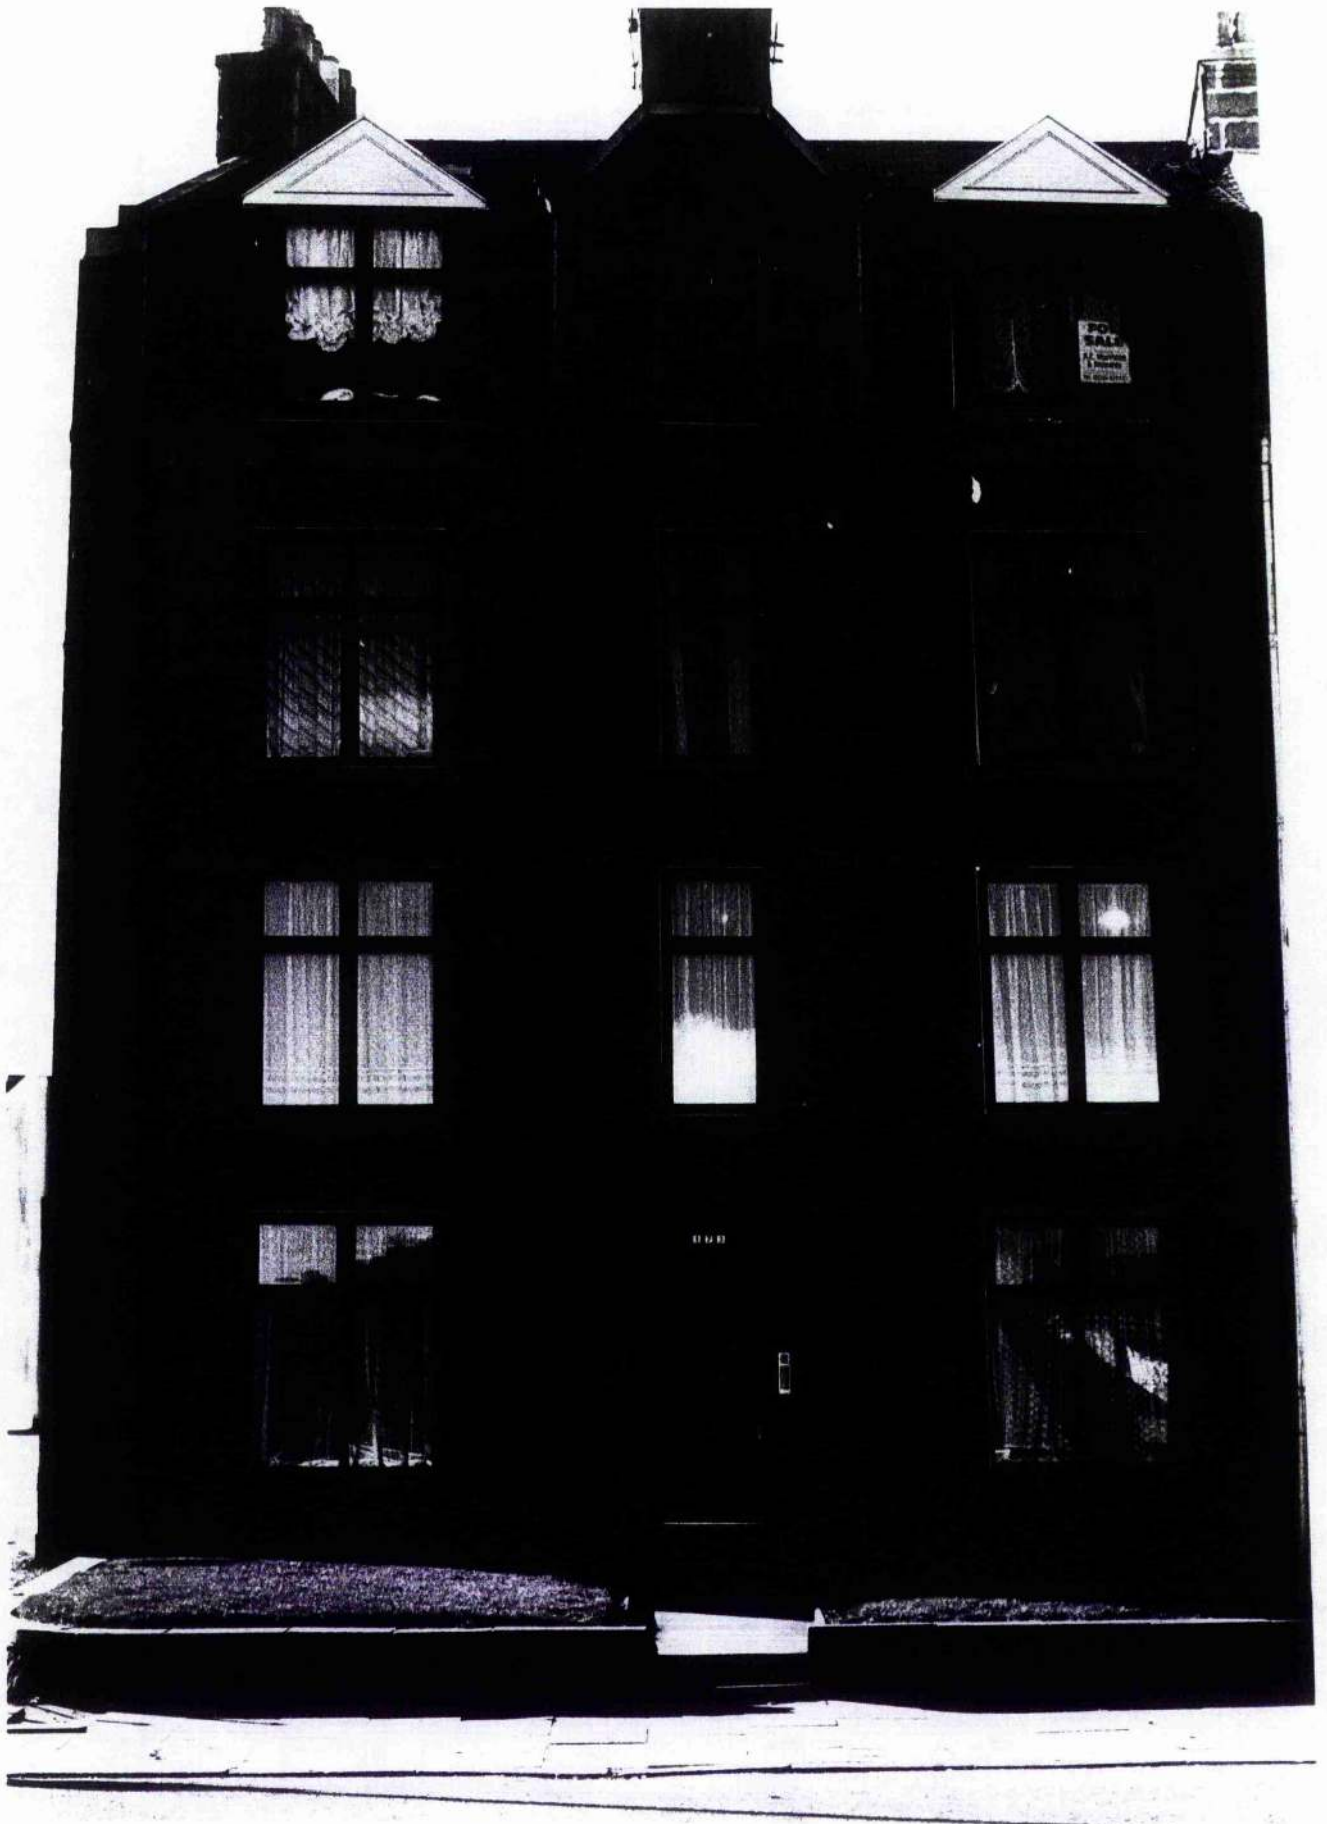
Plate 9.26 171 Great Northern Rd., Aberdeen.

cleaning has left no residual staining. The difference in appraisal of the two buildings is thus quite marked.

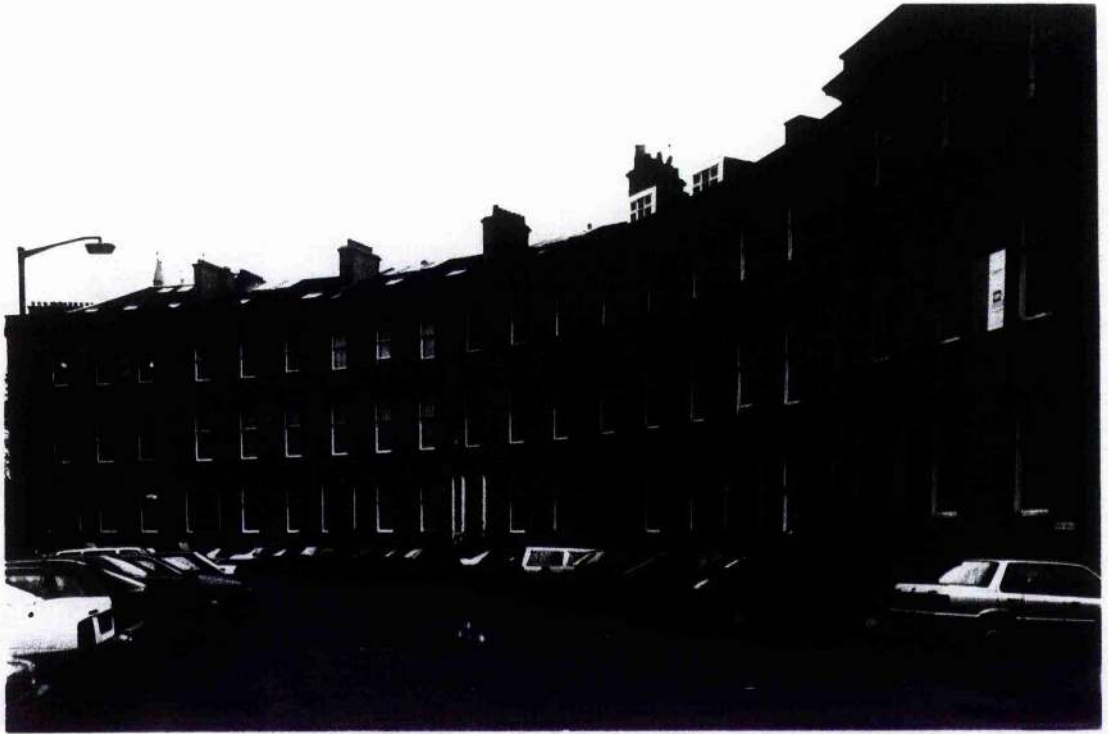
Plate 10.1 22-29 Park Circus, Glasgow.

The aim of the on site surveys was thus twofold. Firstly, to compare evaluations of three terraces which varied in terms of the pattern of soiling and cleaning present on their facades. Secondly, to gather information about the knowledge and attitudes to stonecleaning from as large a cross section of inhabitants of two cities (Edinburgh and Glasgow) which had undergone extensive stonecleaning programmes in recent years.

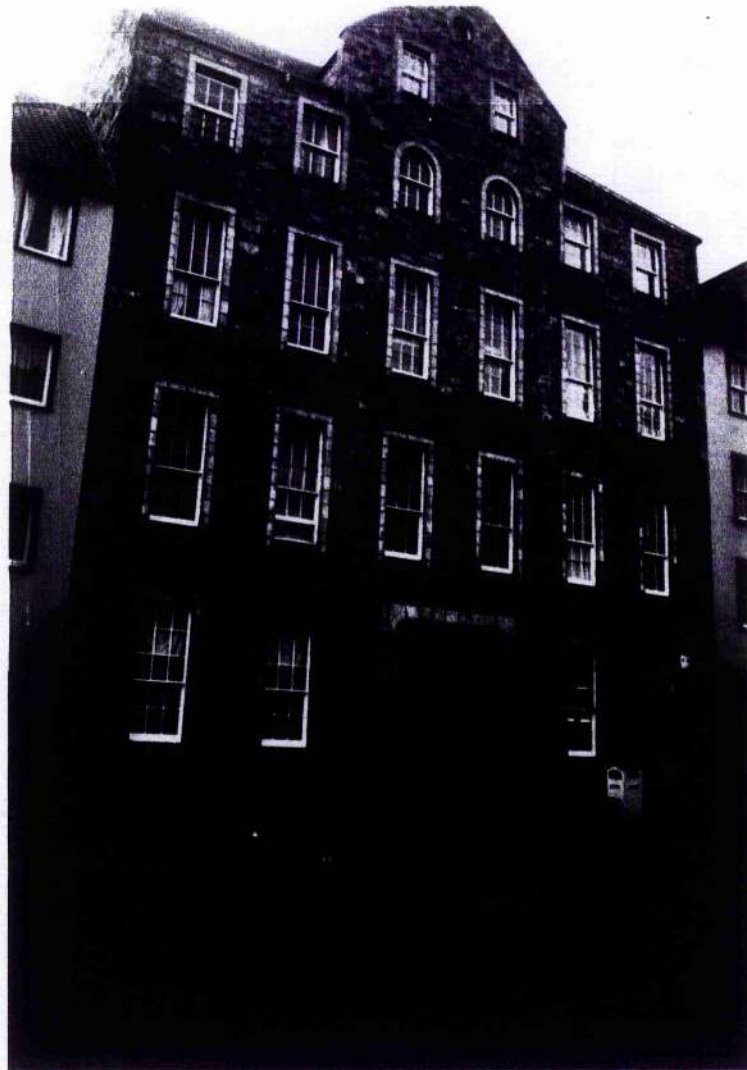
Plate 13.1 224 Royal Mile, Edinburgh.

were in this category included 244 Royal Mile (Plate 13.1), Tolbooth Tavern (Plate 13.6), Lady Stair's House (Plate 13.8), Castlehill School Annexe (Plate 13.11), Castlehill School (Plate 13.14), Tenement, Mound Place (Place 13.17) and 46 Charlotte Square (Plate 13.20). Although there are clearly individual differences in judgment, these appears be situations in which soiling would seem to possibly enhance the aesthetic appeal of particular buildings. The theoretical relationship between soiling and aesthetics is discussed in chapter 14.
